STATIC LOAD TESTING OF A DAMAGED, CONTINUOUS
PRESTRESSED CONCRETE BRIDGE

A Thesis

Auburn University

Auburn, Alabama
May 9, 2009

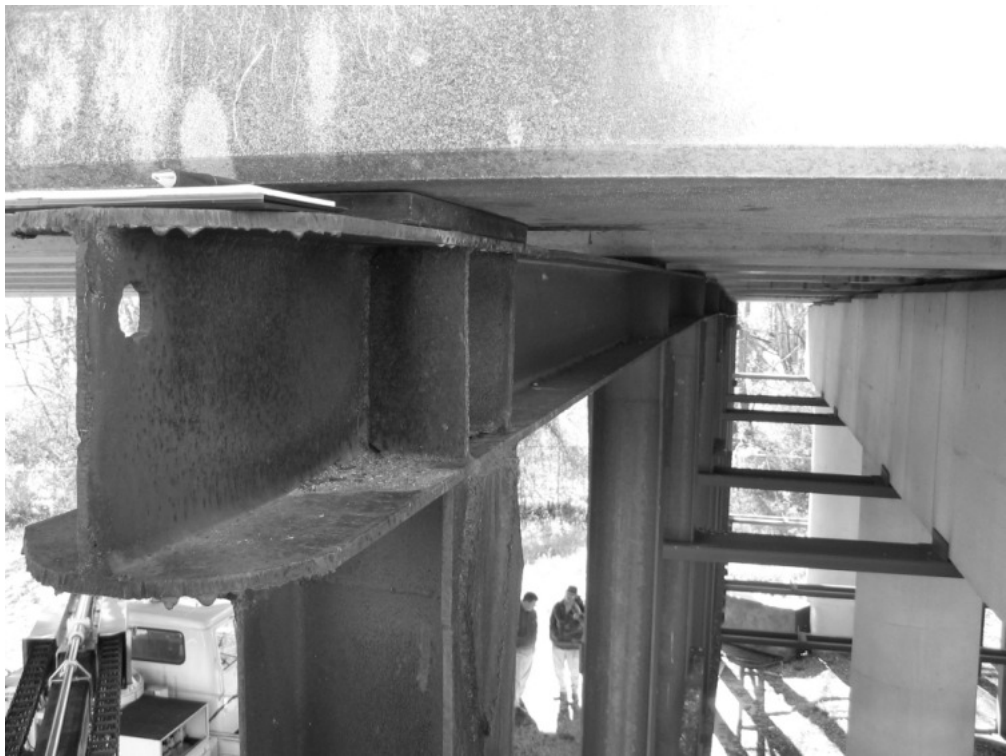
Figure 2-5: Bearing Pad Between Top of False Support and Bottom of Bulb-Tee Girder

After realizing the severity of the cracking, ALDOT personnel quickly took action to rectify the situation. False supports, as seen in Figure 2-4, were installed under all cracked girders to prevent a possible collapse. False supports were installed within 10 feet of the bents. The top of the false supports were placed approximately 1 inch from the bottom of the girder and bearing pads were attached atop the false supports between them and the girder as seen in Figure 2-5. The gap allowed for day to day movements of the bridge due to traffic and thermal loads.

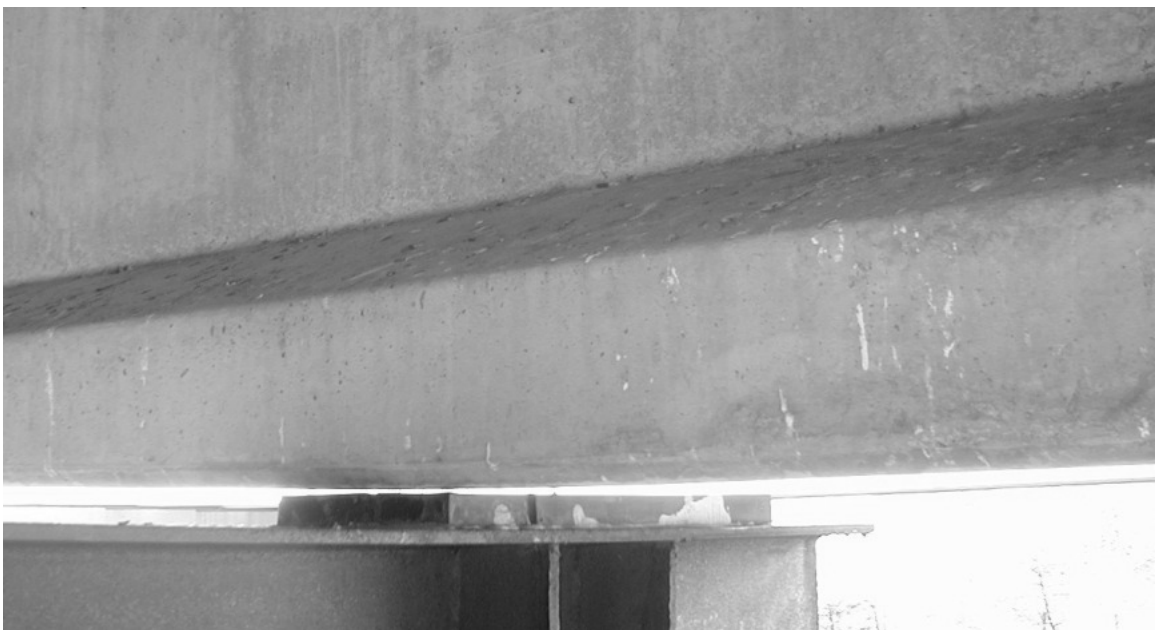
Figure 3-3: Proper Space Between Girder and False Support

approximately six feet from the bent, to be placed one inch below the girder soffits. The one-inch gap was to be partially filled with an elastomeric bearing pad as shown in Figure 3-3. On inspection, it was obvious that the gap between some of the girders and the false supports had been reduced. As depicted in Figure 3-4, a few girders appeared as though they were actually resting on the bearing pads. The small gap or lack thereof caused several concerns. One was whether the girders were depending on the false support for adequate strength. From initial inspection, this was not thought to be the case. The second concern was how to remove the bearing pad if it is being compressed. One final concern was the difficulty of placing the FRP with only $\frac{3}{4}$ " to 1" of clearance between false supports and girders. This issue must be addressed by the FRP installer.

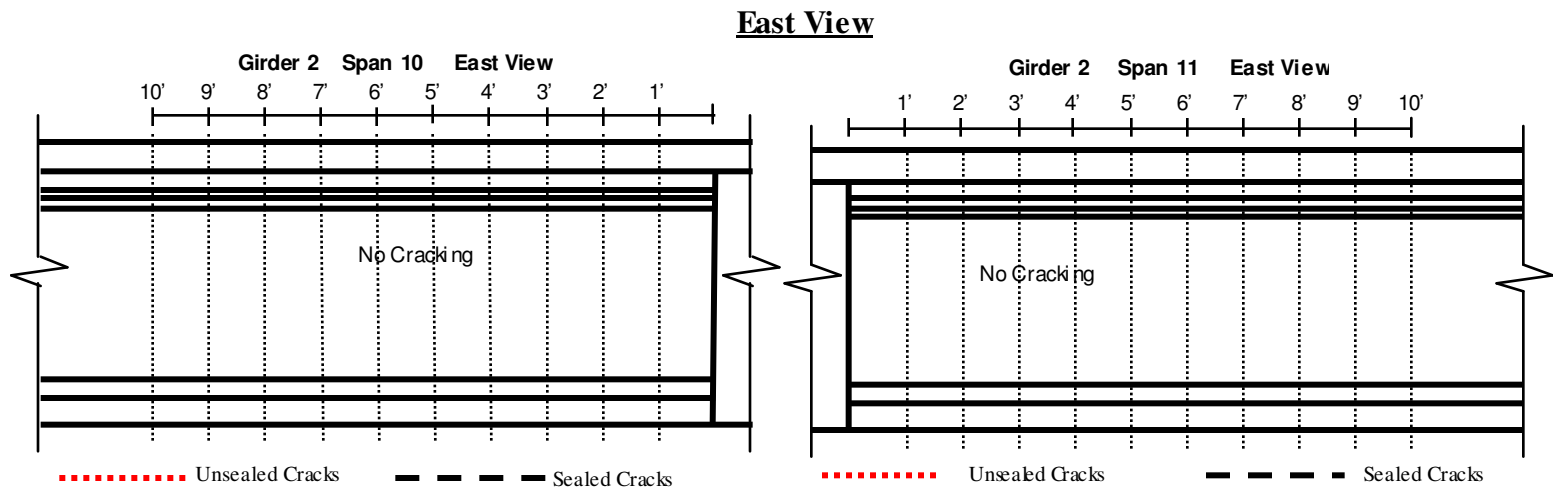
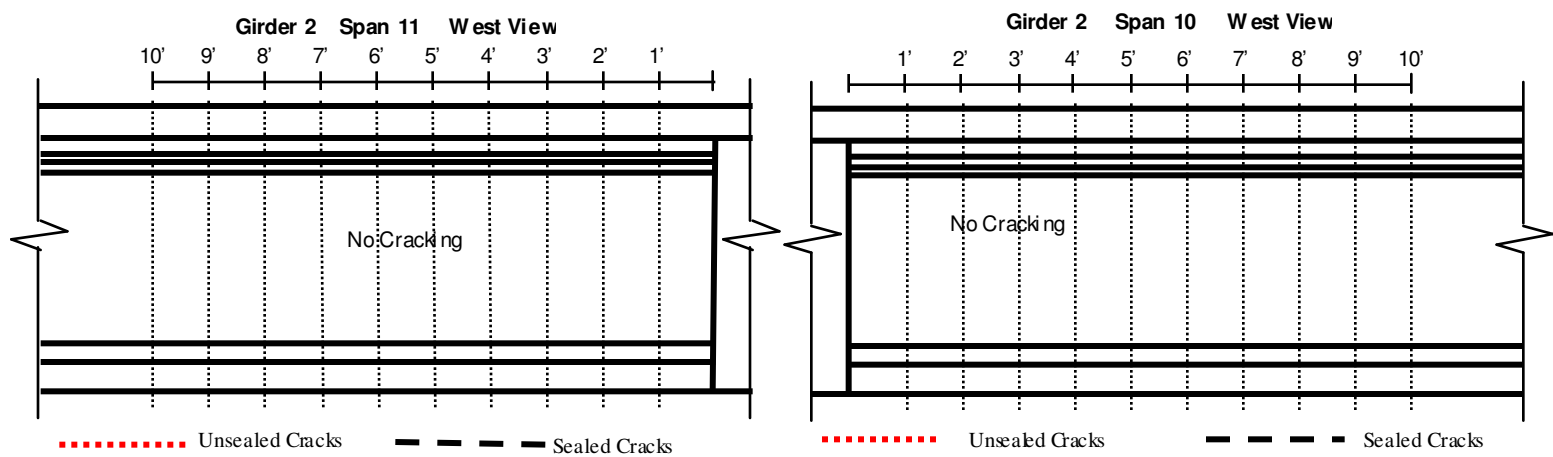
Figure 3-11: Girder Line 2 Cracking

As can be seen in Figure 3-11, Girder Line 2 exhibits no substantial cracking on the girder face. It must be noted that on the Span 10 side, the girder has almost completely separated from the continuity diaphragm. The continuity diaphragm has large cracks and spalled areas near the girder interface. Girder Line 2 is unique in that it does not have serious cracking on the girder faces.

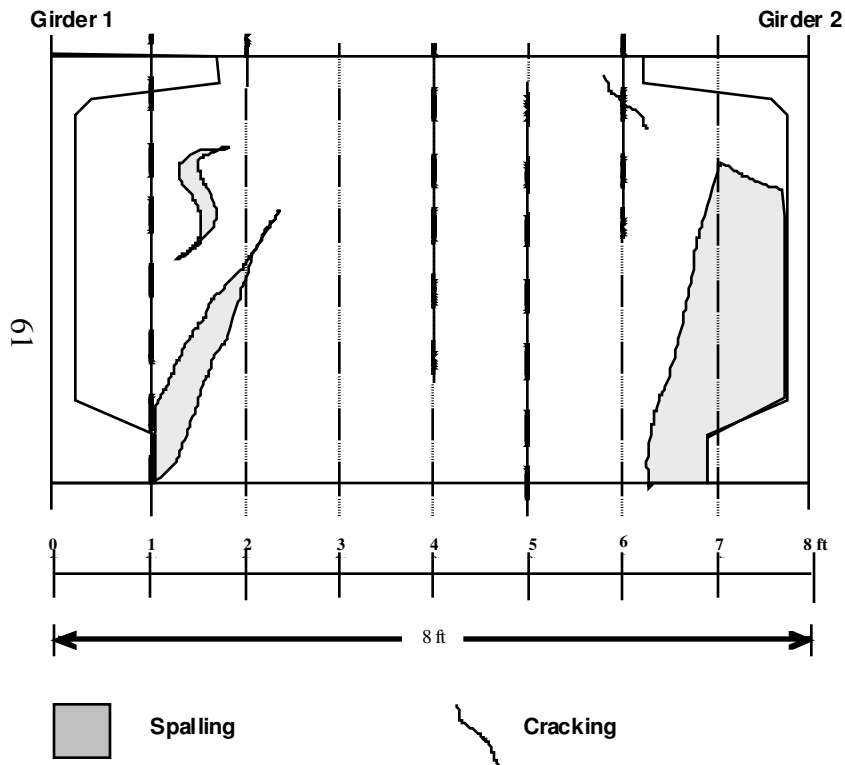
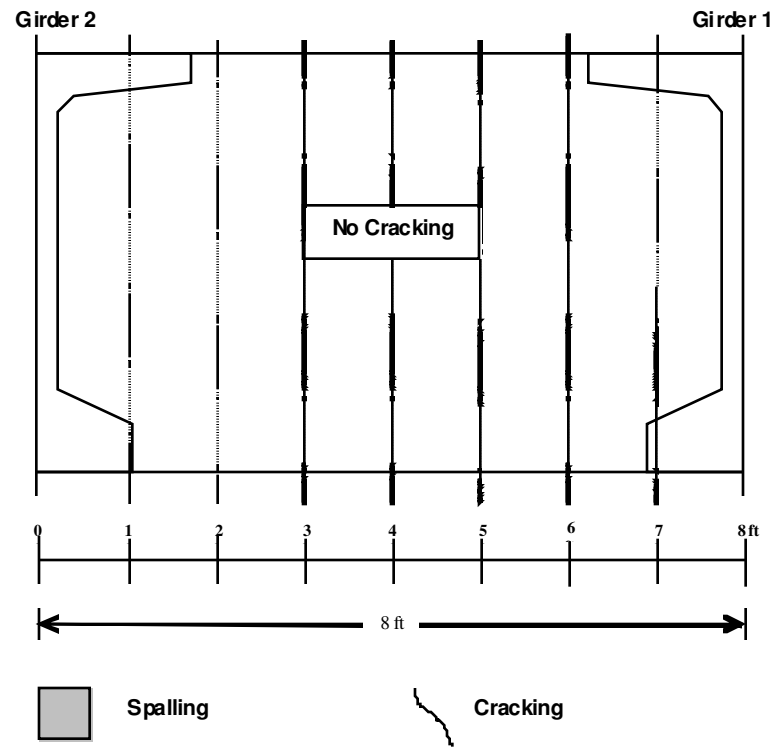
Figure 3-19: Continuity Diaphragm Between Girder Lines 1 and 2

As can be seen in Figure 3-19, large cracks and spalled areas are located on the south side of the continuity diaphragm between these girder lines. There is not much cracking on the north side.

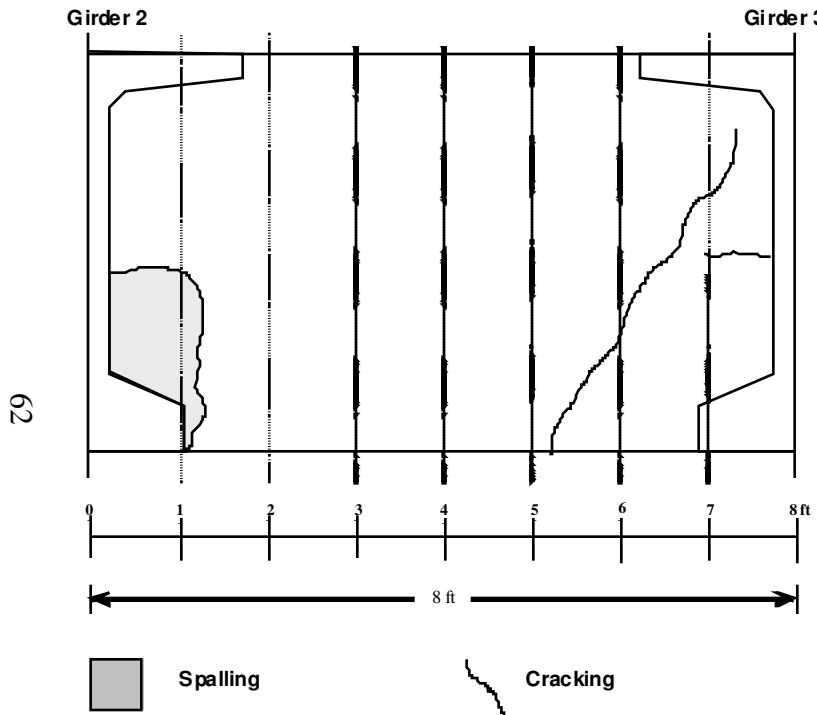
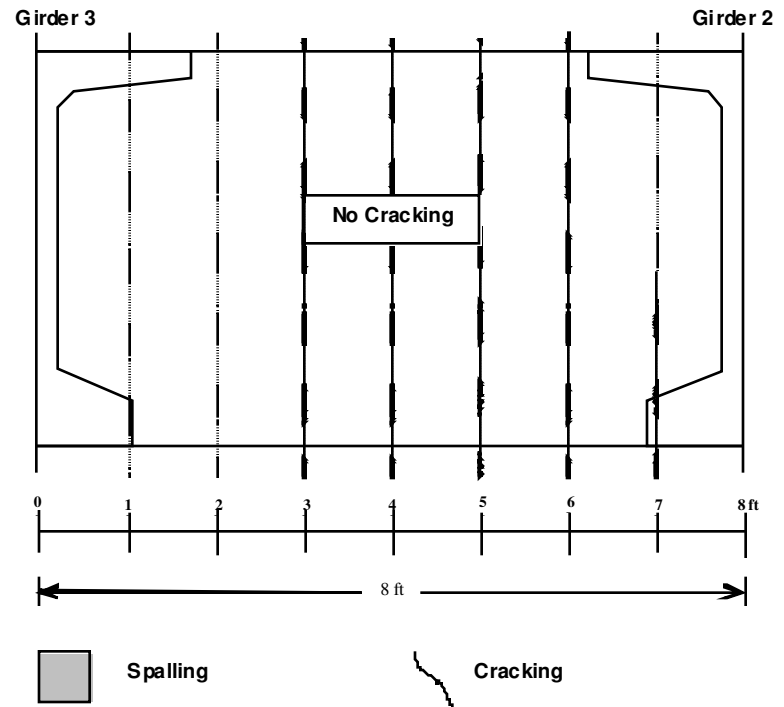
Figure 3-20: Continuity Diaphragm Between Girder Lines 2 and 3

As can be seen in Figure 3-20, cracking and spalled areas are primarily located on the south side. There is not much cracking on the north side.

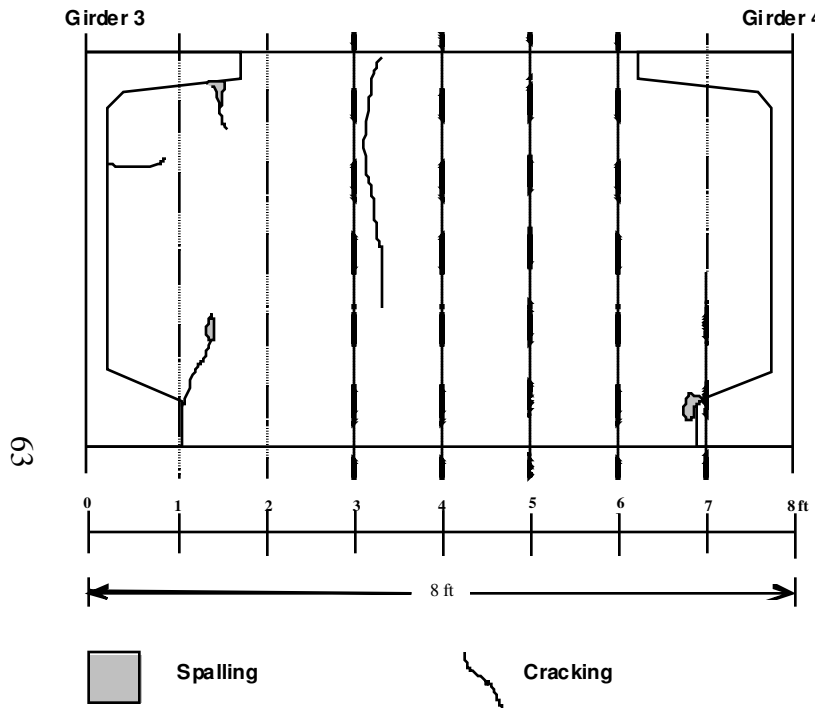
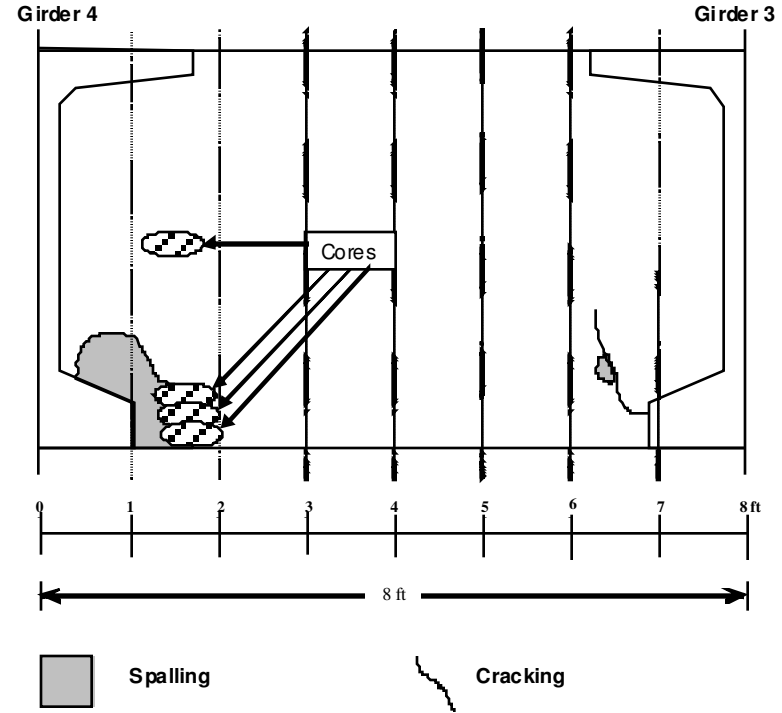
Figure 3-21: Continuity Diaphragm Between Girder Lines 3 and 4

As can be seen in Figure 3-21, the south side primarily exhibited cracks with a few small spalled areas. The north side has large spalled areas as well as several drilled cores from an earlier abandoned attempt to release the girder continuity at the diaphragm.

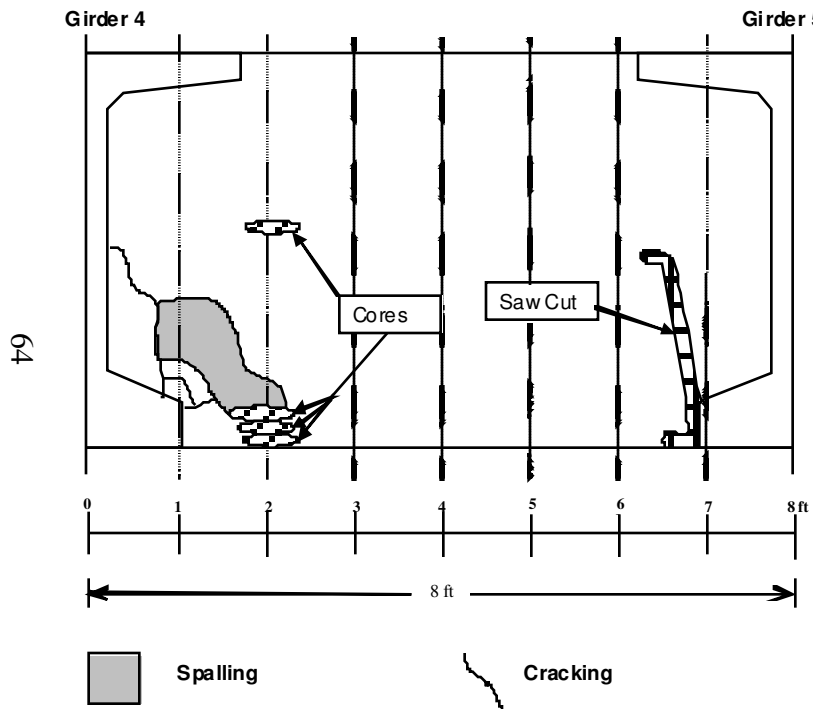
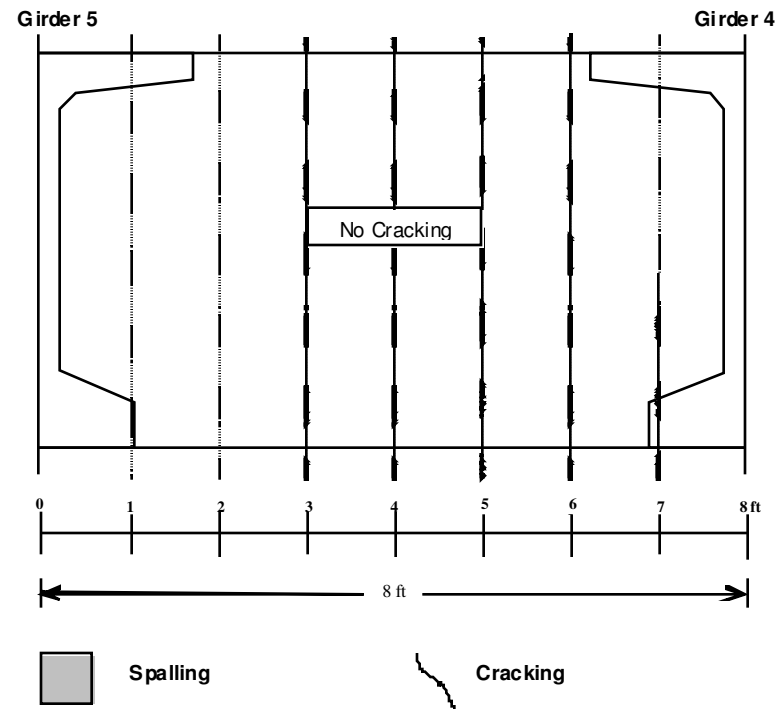
Figure 3-22: Continuity Diaphragm Between Girder Lines 4 and 5

As can be seen in Figure 3-22, the south side has cracks, spalled areas, cores, and a saw cut. There is not much cracking on the north side.

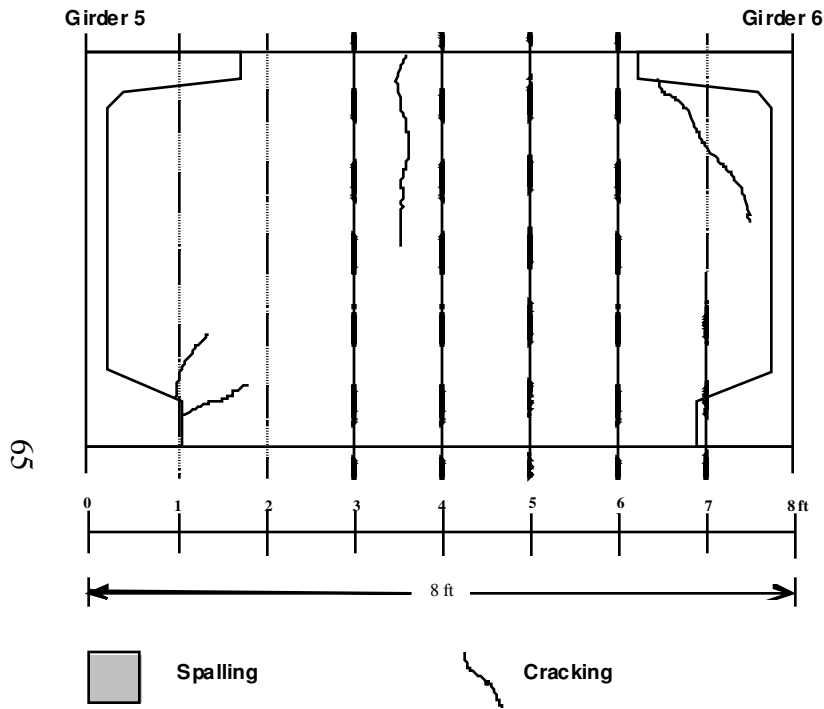
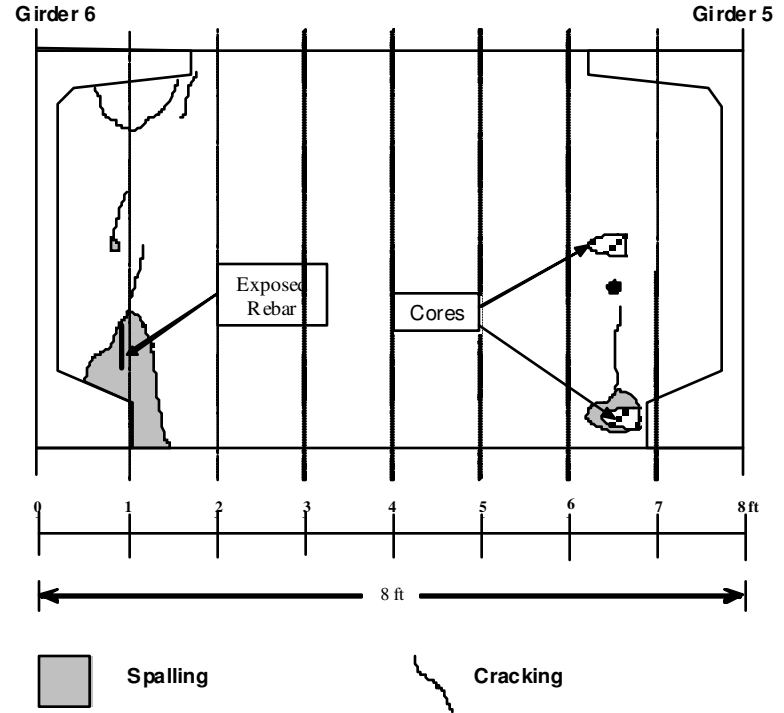
Figure 3-23: Continuity Diaphragm Between Girder Lines 5 and 6

As can be seen in Figure 3-23, the south side has only cracks. The north side has cracks, spalled areas with exposed reinforcing bars, and drilled cores.

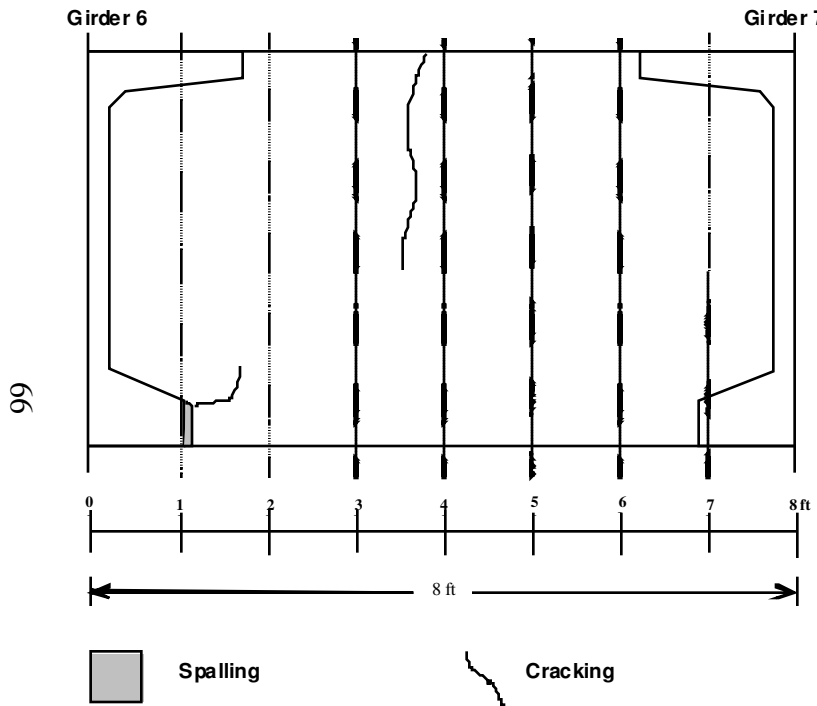
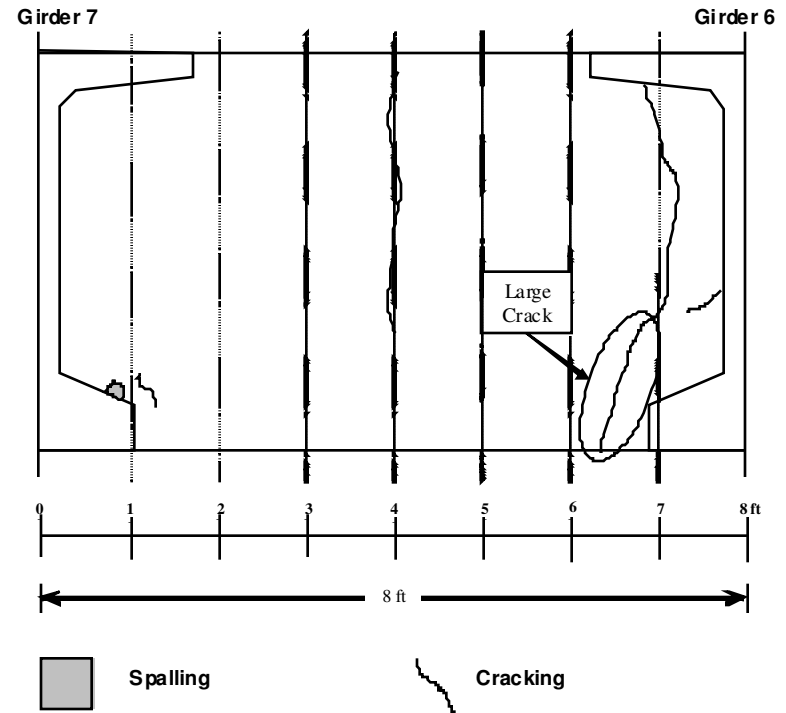
Figure 3-24: Continuity Diaphragm Between Girder Lines 6 and 7

As can be seen in Figure 3-24, the south side has cracking with one small spalled area. The north side has mainly cracking with one rather large crack.

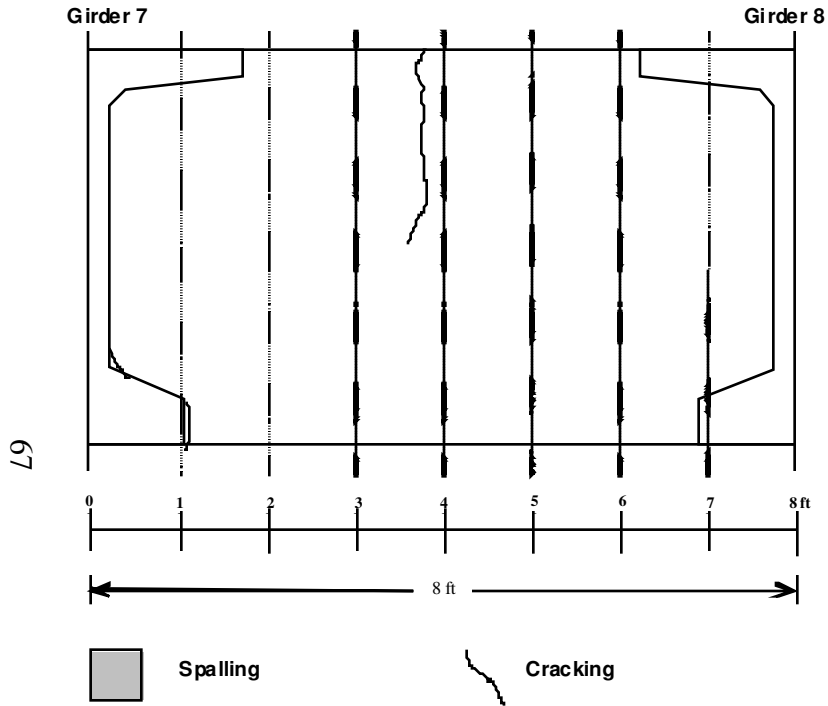
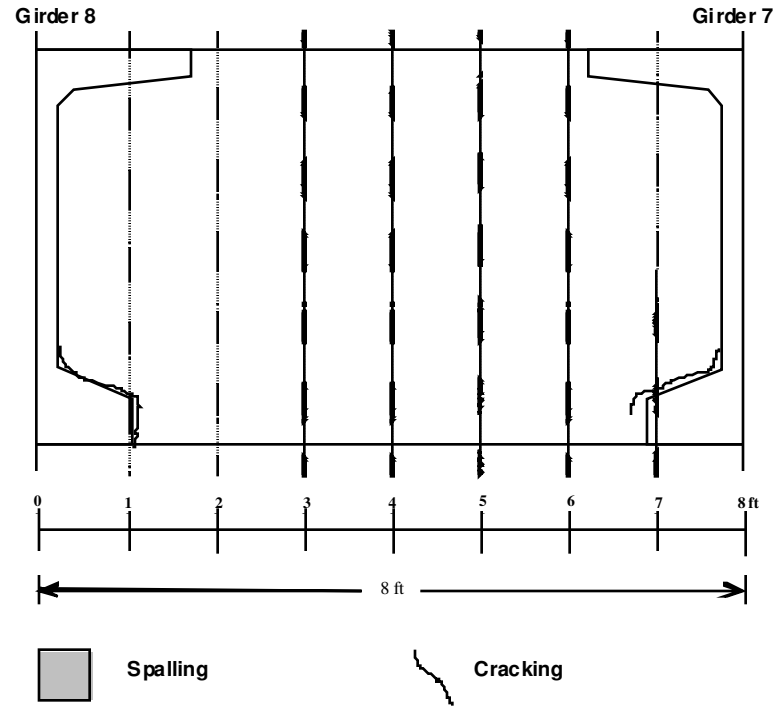
Figure 3-25: Continuity Diaphragm Between Girder Lines 7 and 8

As can be seen in Figure 3-25, both sides have only small cracks.

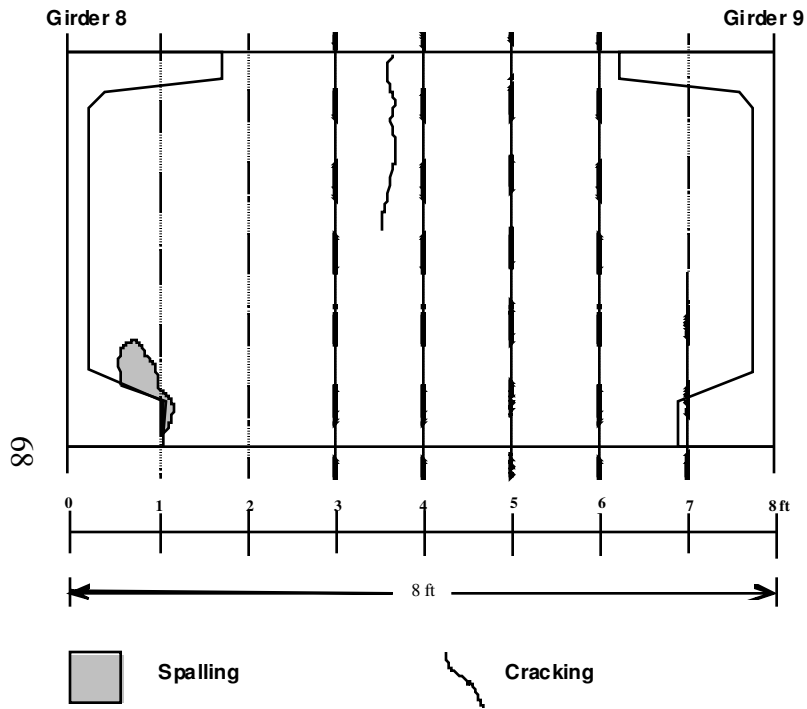
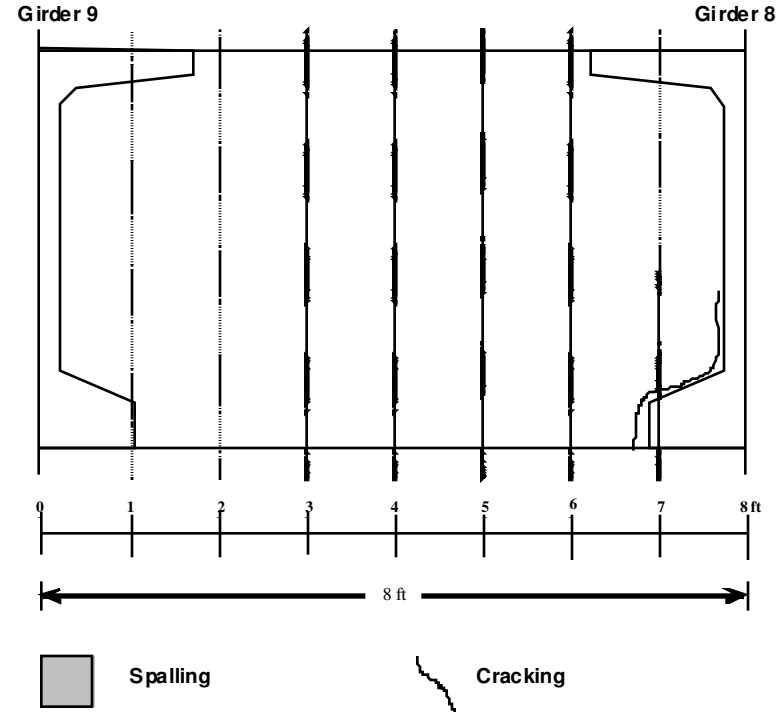
Figure 3-26: . Continuity Diaphragm Between Girder Lines 8 and 9

As can be seen in Figure 3-26, the south side has both cracking and spalling. The north side has only a small amount of cracking.
